DELAWARE RIVER BASIN
HAYNES CREEK TRIBUTARY
BURLINGTON COUNTY
NEW JERSEY

CENTENNIAL LAKE DAM

NJ 00424

PHASE 1 INSPECTION REPORT NATIONAL DAM SAFETY PROGRAM.

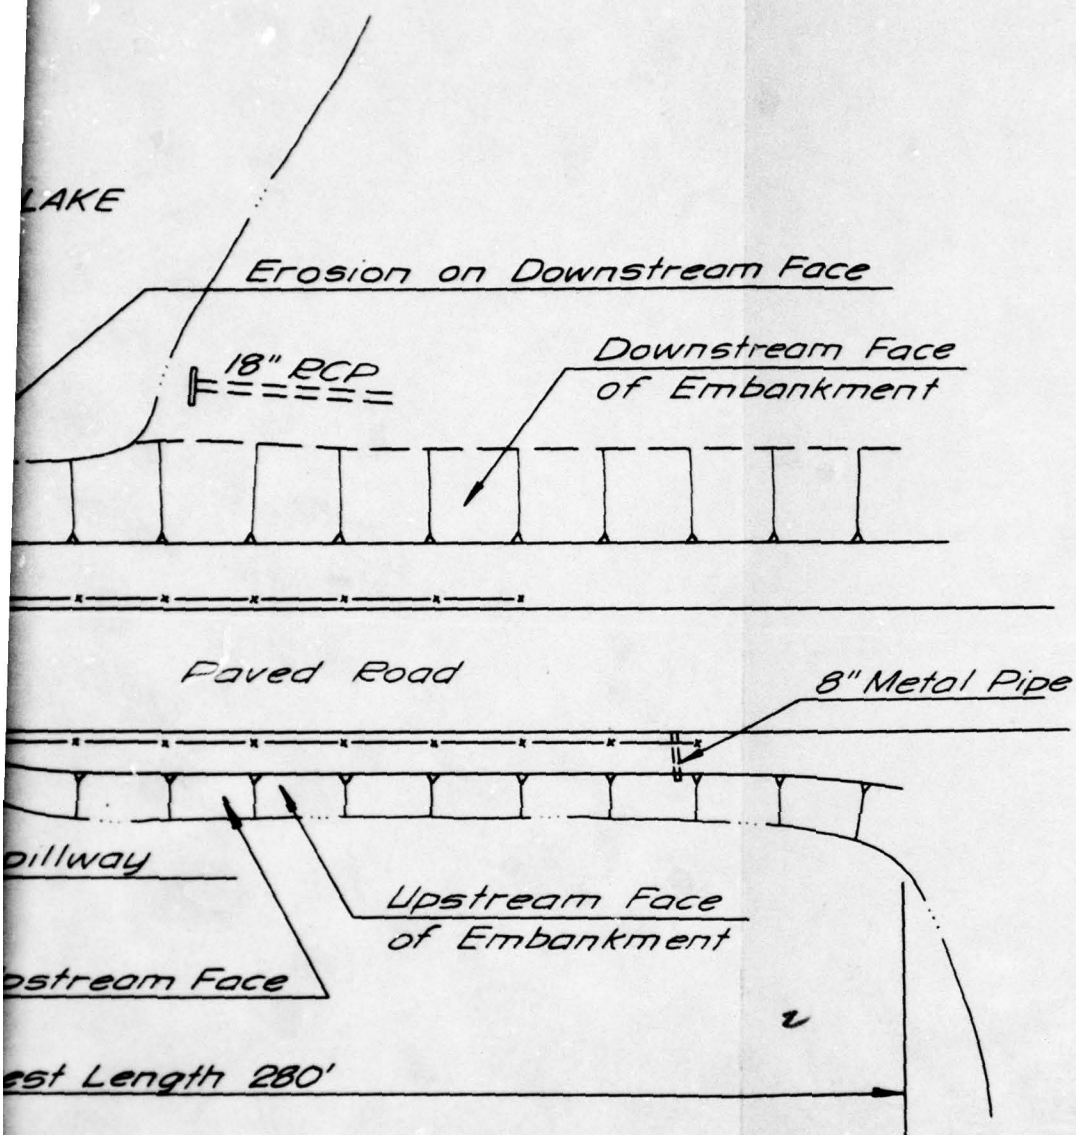
PLATE 4

An 18 inch diameter storm drain outfall with a concrete headwall was observed on the east side of the downstream channel about 10 feet north of the toe of the dam. (See Plate 4 and Photo 5).
